STREAM AND FISHERIES REHABILITATION ACTIVITIES AT FISH CREEK - HYDER

by Paul Novak

Number 7

Alaska Department of Fish and Game Division of Fisheries Rehabilitation, Enhancement & Development

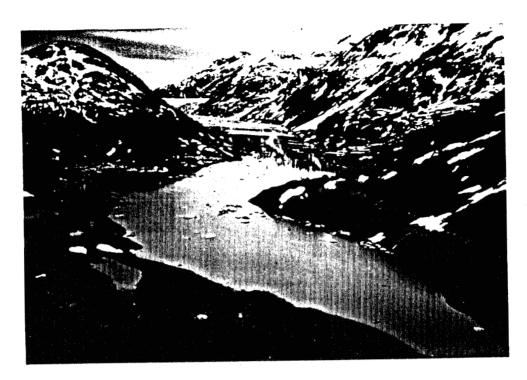
Figure 3. Summit Lake looking toward the glacier on the U.S. Canadian boundary. Low lake levels in July, approximately 15 meters below full pool - "blow out" condition, 1975.

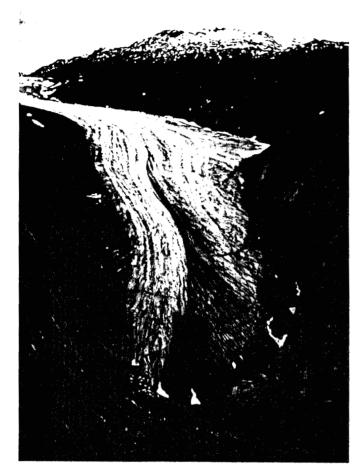
Figure 5. Salmon River glacier under which Summit Lake waters dump into the Salmon River. Outlet tunnel in lower left margin of glacier. 1975.

According to local Hyder residents, mining and logging along the Salmon River, have created environmental changes that may be permanent. My investigations into these comments demonstrated that they were factual. The severe flooding in Fish Creek during the 1960s and early 1970s was caused by damming the upper watershed on the Summit Lake to the Bell Irving River drainage in British Columbia. As a result, Summit Lake (Figure 3 and 4) annually increases in pool size and creates hydraulic pressure that blows out under the glacier (Figure 5 and 6) toward the headwater side of the Salmon River, instead of dumping out on the Canadian side of the Summit. Helle reported that, annually, up to 70,800 l/s of water suddenly dumps into the Salmon River.

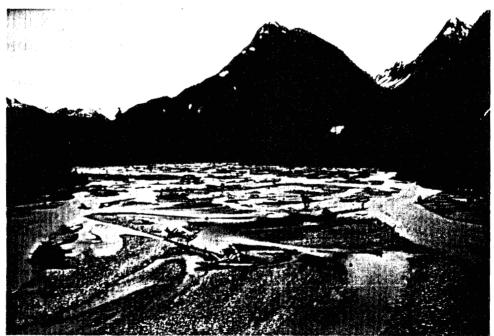
Figure 6. Salmon River flood plain with typical unstable debris and substrate situations. 1975.

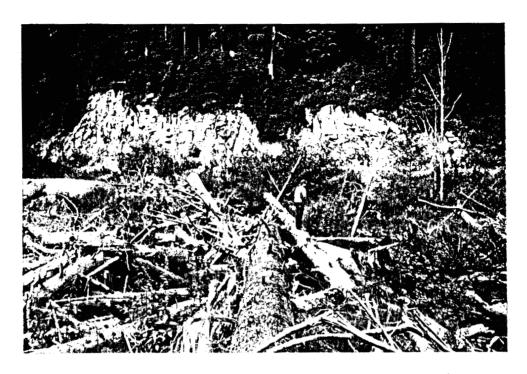
Figure 7. Log jams deposited in 1973, middle spawning area, Fish Creek. 1975.

Annual flood waters carry large debris loads downstream (Salmon River) and deposit large silt-laden gravel bars, boulders, and trees in the Fish Creek area. To protect the road that services Granduc Mining Company's interests near Summit Lake, a dike was built in 1972 by the Alaska Department of Highways and the mining concern. Another high volume flood occurred in 1973 that destroyed 914 meters of road, the dike, and inundated the productive spawning areas of Fish Creek (Figure 7 and 8).

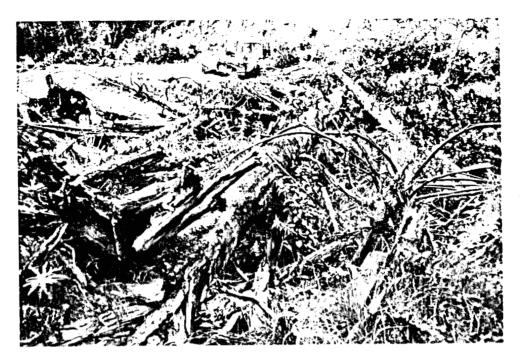
Figure 9. Removal of log jams. 1977.

Protection and stabilization of Fish Creek watershed was the first phase of the fisheries rehabilitation program. Phase two of the program was started in 1977 when the Fisheries Rehabilitation, Enhancement and Development Division (FRED) secured funds for the Alaska Department of Highways to remove log jams and overburdens of gravel and silt from the upper and middle sections of the spawning areas. Instream work was accomplished by tracked heavy equipment between 1-15 June 1977 (Figures 9 and 10).

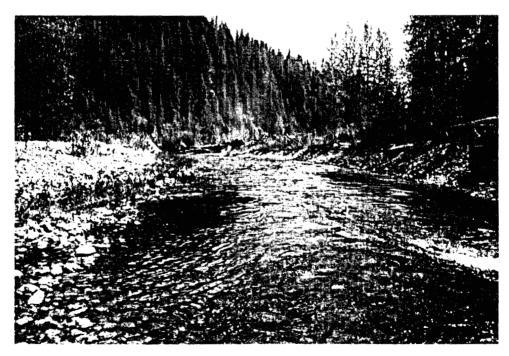
Figure 10. Results of 1977 gravel overburden removal and sculpture of stream banks. 1982.

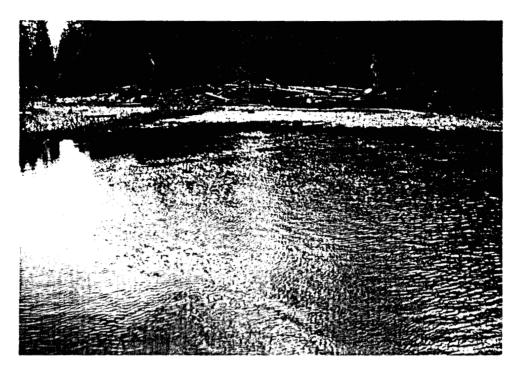
Figure 11. Control sill prior to partial removal in 1982. This 3 foot sill formed a silt ladden pool 250 meters long. 1982.

Stream rehabilitation work continued between cooperating State agencies and the U.S. Forest Service in 1982. Sikes Act monies sponsored removal of a control sill (Figure 11) and effectively reduced hydraulic pressures from the pool formation (Figure 12) to improve upwelling characteristics and encourage fine material flushing. Approximately 0.76 vertical meters of the sill was removed (Figures 13 and 14). Midstream island formations (Figure 15 and 16) were removed from the productive chum salmon spawning areas in Fish Creek. Improvements in the substrate condition were detectable immediately (Figure 17).

Engineers and hydrologists are planning for removal of an additional 0.30 meter of the vertical sill in the lower spawning area. This action will improve gradient and lateral flow conditions and should reestablish natural upwelling in the area.

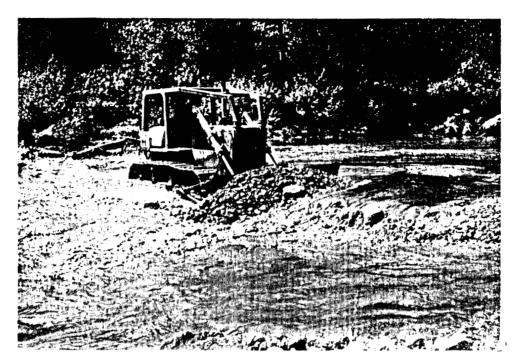
Figure 13. Removal of sill and flood waste deposits. 1982.

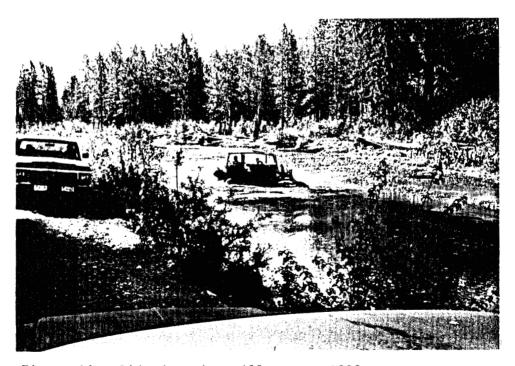
Figure 14. Side dressing sill area. 1982.

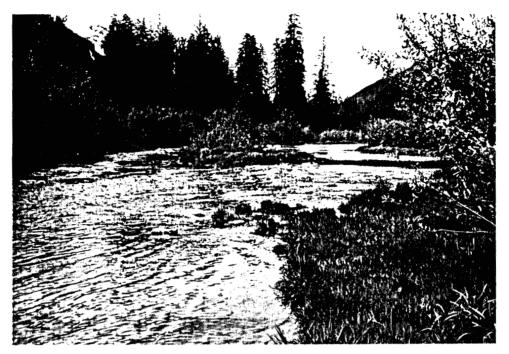
Figure 15. Midstream island - midsection of spawning area. 1982.

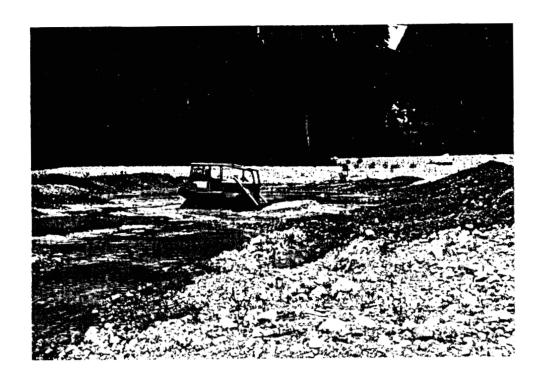
Figures 20 and 21. Enlargement and deepening of the headwaters of Marx Creek for improvement of upwelling water collection. 1982.

Instream work on this 3.2 km evolving system included definition of channel (Figures 18 and 19) and improvement of upwelling water collection (Figure 20 and 21) in the headwater area. Channeling the system has improved flow and gradient characteristics, thereby decreasing the fine materials (Figure 22 and 23) in the substrate. Like Fish Creek, the upwelling ground waters in Marx Creek should provide excellent opportunities for high survival (green egg to emigrant fry). Future stream enhancement opportunities at Marx Creek will be planned and investigated by the U.S. Forest Service and the Alaska Department of Fish and Game. Potential exists to:

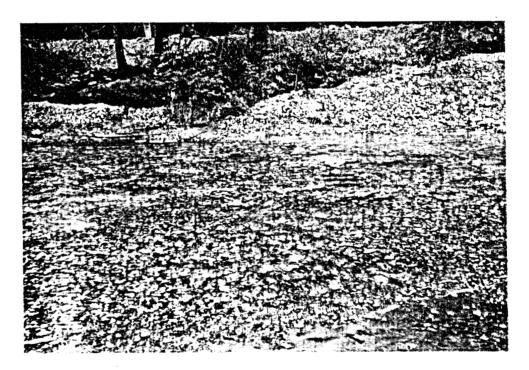
Figure 23. Spawners distributed in the channeled portion of Marx Creek where silt loads were tremendous prior to channeling efforts. 1982.
